OREGON SHPO CLEARANCE FORM

Determination of Eligibility

Property Name: Milwaukie High School

Project Name: Milwaukie High School Modernization

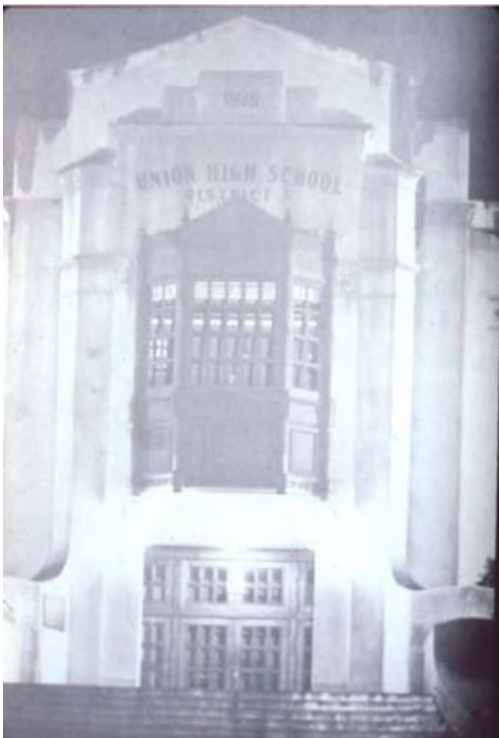
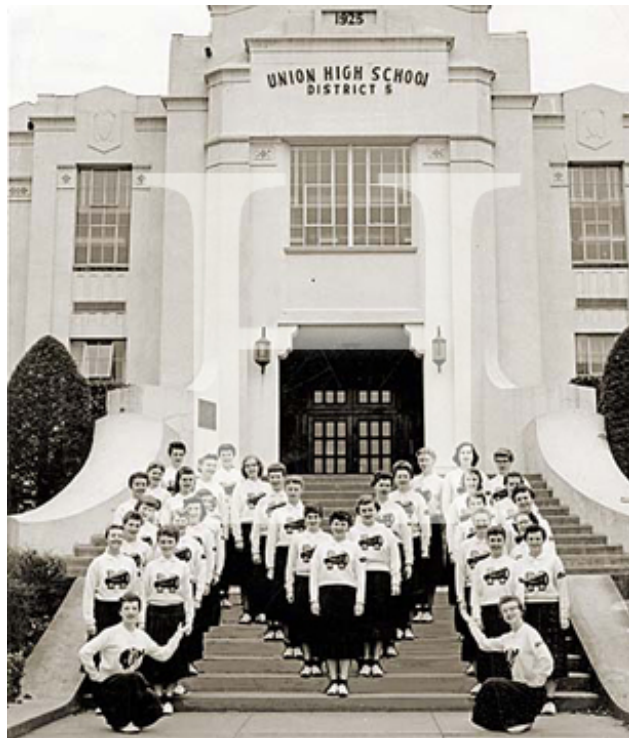
View 5: Front entry of Milwaukie Union High School (left: c1940, North Clackamas School District; right: 1956, *Oregon Historical Society* archives)

The 1925 primary building's west-facing volume with central main entry retains much of its original exterior features and materials. The front entry bay was remodeled several times; most significantly in 1958 and in 2000. See *Views 5 and 7*. Despite these changes, this front "bar" volume has its original pattern of openings and decorative features in the Art Deco style. The interior retains its general central corridor layout with classrooms and primary stairs. In 2000, windows were all replaced from the original steel multi-pane windows of varying operation (fixed, hopper, casement) to aluminum windows with insulating glass and applied multi-pane divisions. Some windows may have been replaced prior to that date as well. In most cases, the drawings show a new aluminum frame encasing the original steel frame. The original auditorium volume in the center was radically altered in 1971 to become a media center. None of the interior is identifiable as the original stage & proscenium, raked seating and balcony, or other features. The 1938 north wing retains its original interior layout for the most part. The 1949 south wing also retains its original corridor layout, though the classrooms have been enlarged into what was initially corridor (2000).

In general, the main academic building maintains the aesthetics of the 1920's Art Deco style, but certain portions have drastically changed since its primary construction. The most drastic changes are associated with the main entrance, which first had a projecting wood bay removed at the second level sometime prior to 1955. The entry was lowered during the 1958 renovation when the basement level became the main point of entry to increase the number of classrooms on the first floor. The main entryway that had exhibited a recessed metal-frame double door was replaced with a metal-cladded bay window with a decorative framework. This bay window was replaced sometime before 1965 with a large gridded, tripartite single-hung window that mimicked the one located above it. The building's foundation is no longer a heavy-weighted concrete mass, but now contains a corridor that runs alongside the building that was carved out around the same time that the main entrance was renovated. A gridded double door now serves as the current entrance at the lowered level and is recessed under the corridor's protruding overhang. The original wide cement steps that led up to the original entrance and were contained by flaring white stucco walls were flattened out when the ground level was brought down to the basement.

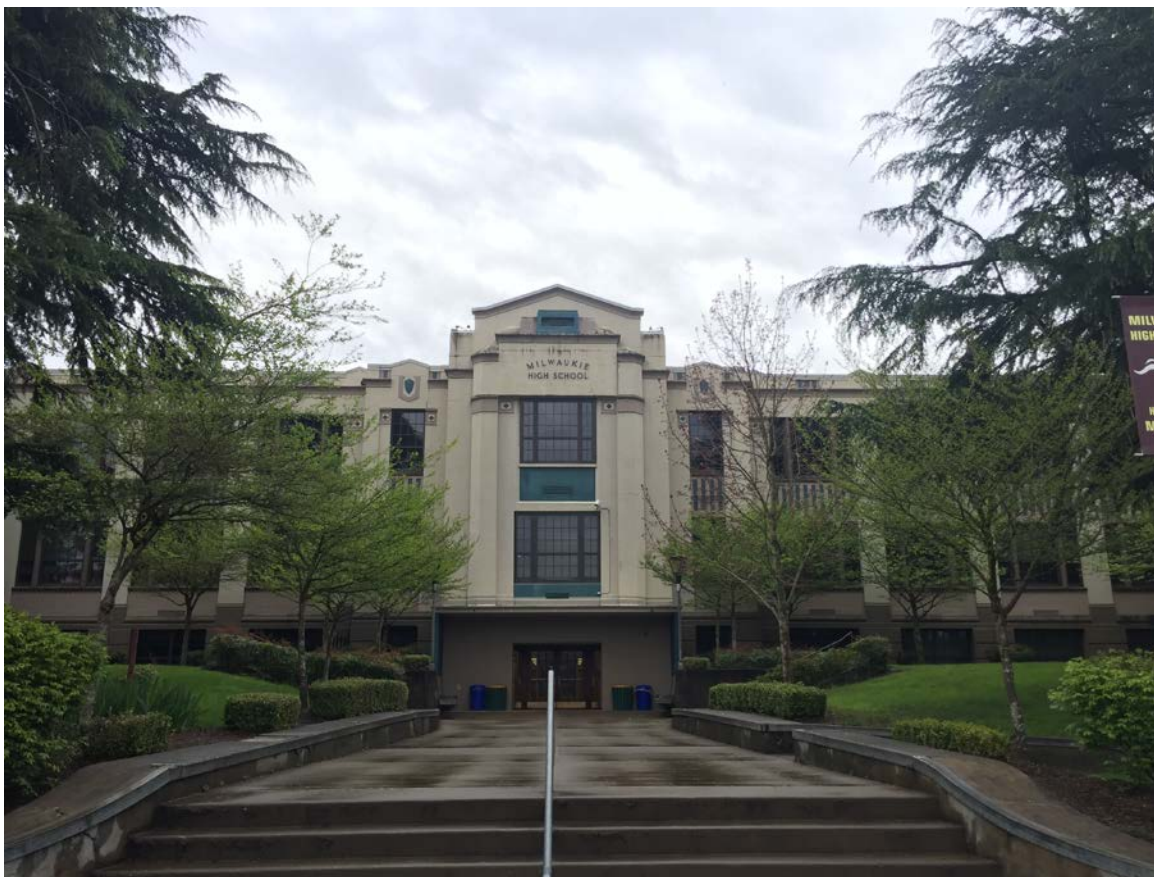
View 7: A photograph looking east at the current Milwaukie High School's main façade

Alterations to the upper portion of the main façade have preserved the building's original appearance and continue to emphasize the verticality of the Art Deco style. A pair of enlarged trapezoidal pilasters frame the two central windows above the main entrance, the original parapet wall extends upward from behind the central frieze, a series of staggered cornices border the entire expanse of the building, and an array of evenly-spaced full-height pilasters with decorative plaster capitals step along the main elevation. The original cream-colored, steel multi-pane windows that ran along the entire façade between these pilasters in a 1956 photograph have been replaced with gridded aluminum-sash, single-hung windows with operable side hoppers. These windows are lined at their bases with a continuous brick sill that appears to be the same one present in 1925. The original lettering on the frieze that once read "Union High School District 5" was replaced sometime after 1974 but before 1983 with lettering in a similar font style that reads "Milwaukie High School". The school's name also read less visibly directly above the current entrance doors, but has been taken down within the past decade.

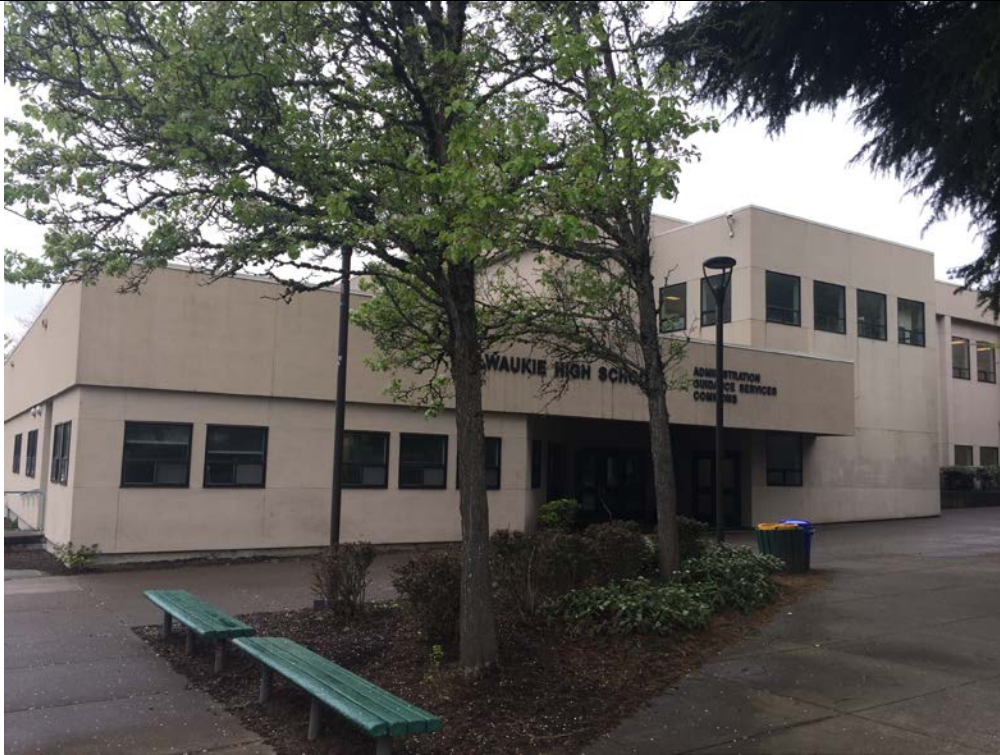
View 8: The southern façade of the Commons Building that includes Administration offices and guidance services.

1993—The Commons building was constructed as an addition to the north side of the main building. It had a “bridge” connection to the main building at the second floor level, and also a connection directly to the Gym. The Commons included a kitchen with cooking, preparation, serving, and dishwashing area, as well as the commons space and administration offices. The second floor was developed with a teachers' lounge, a balcony, and open sky-lit space.

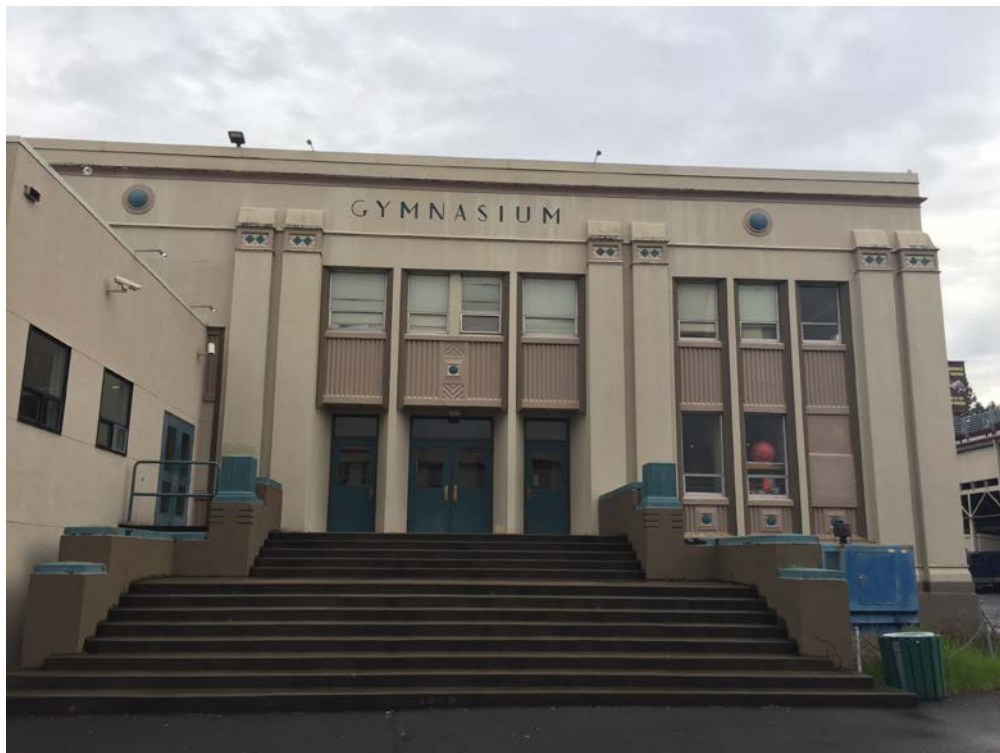
View 9: A portion of the southern façade of the gymnasium, the oldest section of this building.

1938—The original gymnasium was constructed to the north of the main building and boiler room, with 23rd Avenue on its west side and its entrance located on its southern side facing the original buildings. The gymnasium contained girls’ and boys’ locker rooms, dry rooms, a balcony space, an apparatus room, and a small corrective exercise room.

1953—The new western addition to the old gymnasium contained new classrooms, relocated locker rooms and dry areas, and a wrestling room, practically doubling the building in size. Both portions of the gymnasium were remodeled to include a single wrap-around interior balcony with access to a new tumbling room over the original southern entrance.

1963-64—A fire in July 1963 caused major damage to the gym, “gutting” it and destroying the roof and interiors. An article in the *Oregonian* (September 20, 1964) notes that a “new gymnasium- which replaces one destroyed in a fire two years ago- is about ready for occupancy.” Drawings or information on what was lost or rebuilt are not available.

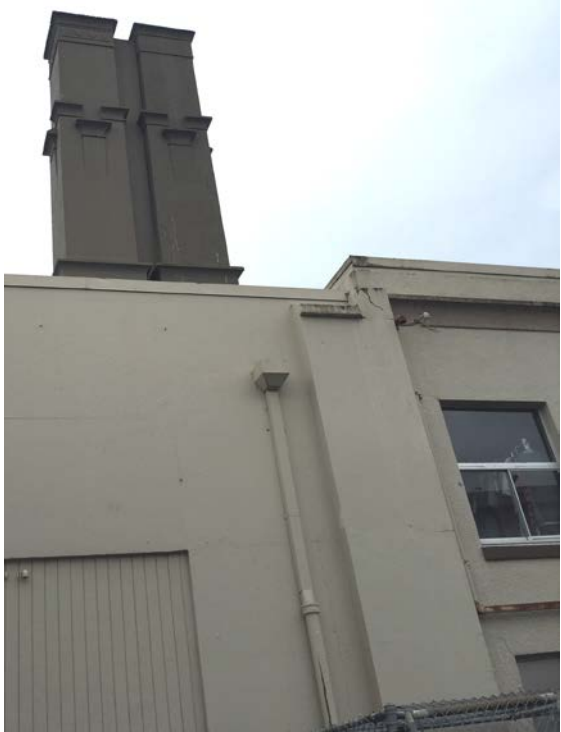
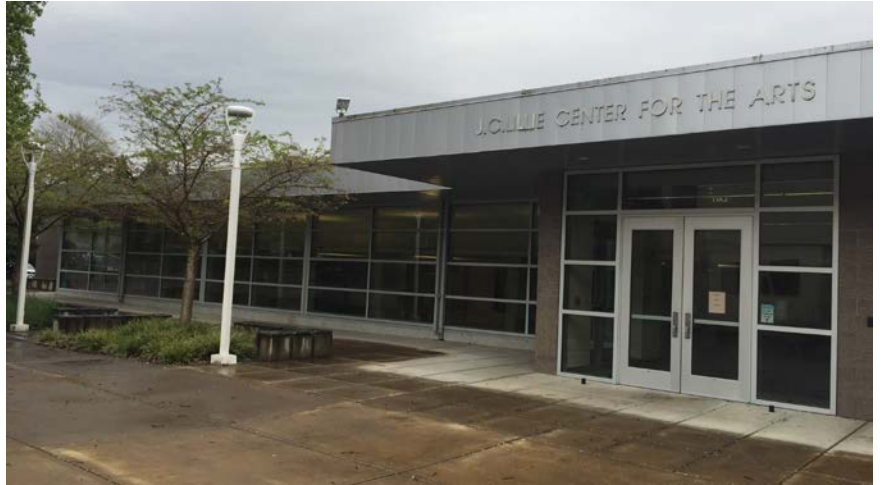
View 10: At left: looking up at the south side of the paired chimneys at the Arts & Crafts/ boiler building. At right: The eastern façade of the J.C. Lillie Auditorium.

The Arts & Crafts/ boiler building has been enlarged and altered significantly, but still retains original features such as the decorative chimney. The earliest, 1925 portion of the building is the square volume furthest to the west, which originally had only one chimney (see *View 2, Sanborn map*). The 1949 addition was larger than the original volume, and T-shaped in footprint. It added a second chimney attached to the first, which matches the first but lacks some of the finest-scale decorative embellishment. The Arts & Crafts/ boiler building has only fair integrity overall, but could be considered a contributing outbuilding to the primary school building.

2008—The auditorium was converted into the *J.C. Lillie Performing Arts Building* with the addition of a new art department and dance studio section on the northeastern corner of the building, a renovation of the band room on the northwestern corner, drama room remodel on the building's southern side, the addition of a black box theater on the southeastern corner, and a new lobby addition on eastern face of the auditorium. The Business Education Building that was located immediately southeast of the auditorium was demolished to make way for these additions.
